FAA Tests E- and H-field Antennas to Characterize Improved Loran-C Availability During P-Static Events

Dr. Robert Lilley Aviation Management Associates, Inc. Robert Erikson, ACB-440 Federal Aviation Administration, William J Hughes Technical Center

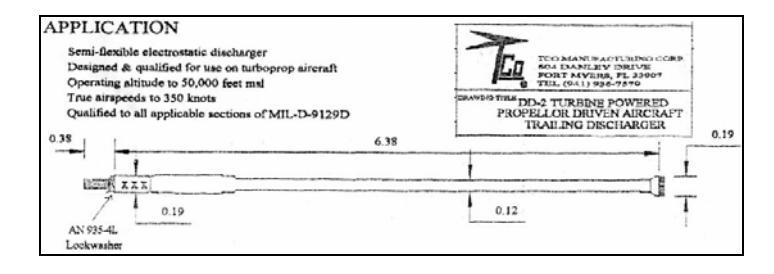
Figure 2: TCO DD-2 discharger [3].

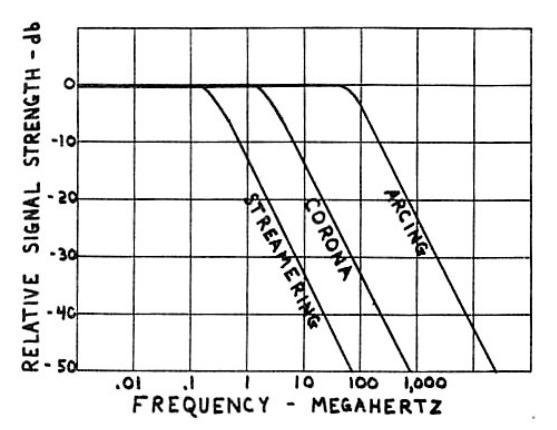
Figure 3: Noise caused by electrostatic charging [4]

airframe, particularly during severe charging encounters. Inflight separation of the electrical noise observations into the elements discussed above is difficult. As shown in Figure 3 [4], the three processes are most energetic at the lower frequencies, but corona and arcing can cause interference well into the high-frequency (HF) and very-high frequency (VHF) bands and beyond.

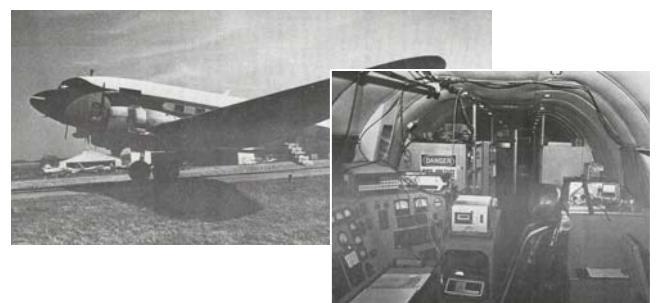
Figure 4: Ohio University DC-3 N7AP, 1982

The DC-3 tests included installation of discharger devices instrumented so that discharge currents could be measured, a field mill for determination of the electric field and potential associated with the airframe, and a data collection package. See Figure 4.

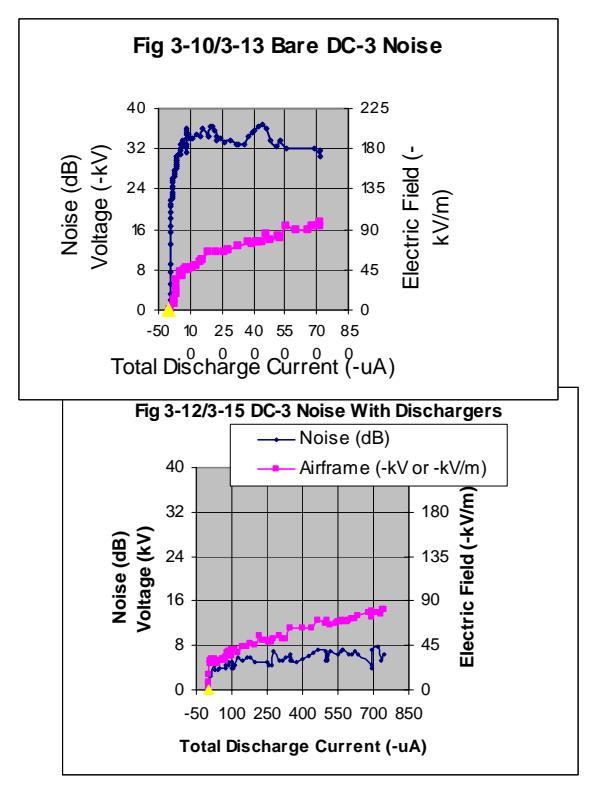
Figure 5: DC-3 (1982) with and without dischargers in simulated p-static.

Figure 5 gives relevant results for the DC-3 ground test. The "bare" airplane was simulated with 1/8" brass rods replacing dischargers, to produce corona discharges which were not decoupled from airframe trailing edges. This configuration provided data typical of a craft which may have had broken discharger units, or none at all. Figure 5 (upper panel) shows clearly that the aircraft experienced over 30 dB of noise increase in the Loran-C band almost immediately when corona discharges began. When resistive dischargers designed for low-frequency quieting were installed (lower panel), a 24-dB reduction in noise was evident up through 100 μ A of discharge current. Even at discharge rates considered "severe" or "unusual" in practice, fully 17 dB of quieting was noted.

The dischargers, by acting somewhat like Zener diodes to keep airframe potential lower, and by providing a decoupled path for equalization of charge with the atmosphere at lower electric field strength, significantly "quieted" this airframe. Loran-C would perform better, even with a well-designed efield antenna! The flight tests are reported [8] to have confirmed the ground test results, but the traditional difficulty of locating natural-charging conditions on demand was noted. Onboard static charging of the airframe was successful, and airframe-quieting results similar to those above were reported. It was pointed out that onboard charging is convenient and controlled; minimized flight-time and stable electric-field conditions were pointed out as advantages.

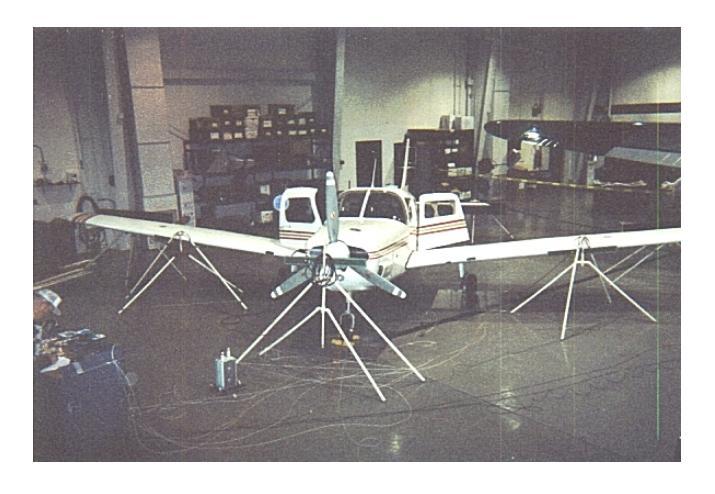
Figure 6: Ground Electrostatic Survey underway on Piper Saratoga N8238C, 1999 [10]

Within the FAA Loran-C evaluation program, Illgen Simulation Technologies performed a study [10] including modeled Loran-C availability-of-accuracy estimates for allin-view receivers and a ground electrostatic survey of a Piper Saratoga aircraft, N8238C. The airplane is owned by the Ohio University Avionics Engineering Center, and the tests were carried out in Ohio with the cooperation of the Center. Figure 6 shows the electrostatic test underway.

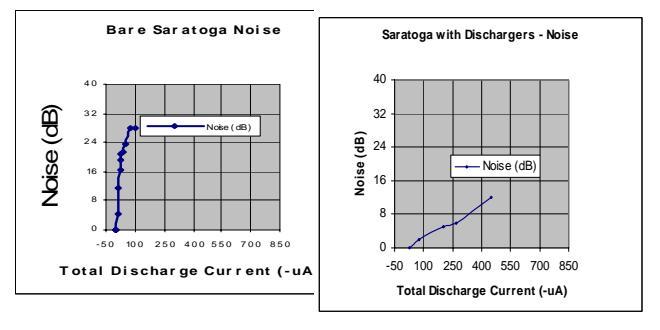
Figure 7: Saratoga N8238C (1999) with and without dischargers in simulated p-static.

Figure 7 shows results of the ground charging test on the Piper Saratoga. The data clearly showed a 16-dB rise in p-static noise even at very low discharge currents (26 μ A). A Loran-C receiver operating on this aircraft could experience this 16-dB SNR reduction upon entry into almost any cloud formation.

With a set of dischargers designed to reduce low-frequency p-static noise, the 1999 tests showed airframe quieting of approximately 24 dB at 100 μ A, and projected low noise out to 250 μ A discharge current. This represents a major improvement in airframe noise performance.

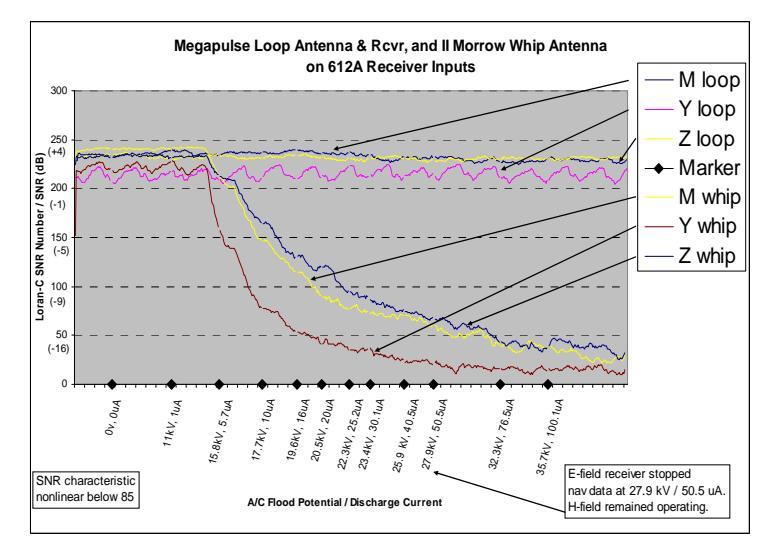
Figure 8: E-field and H-field comparison, Piper Saratoga N8238C (1999); no dischargers

A paper on p-static performance comparing e-field and h-field antennas would not be complete without reference to the often-quoted Loran-C data collected during the 1999 tests. Figure 8 shows this comparison, which is typical across receivers and across airplanes. More than 20 dB separated the relatively unaffected h-field traces and the simultaneous e-field traces, much of the difference occurring prior to reaching 50 μ A of discharge current (without dischargers). Once again, with dischargers, even hundreds of μ A would be expected to cause less noise and not to affect the h-field antenna noticeably.

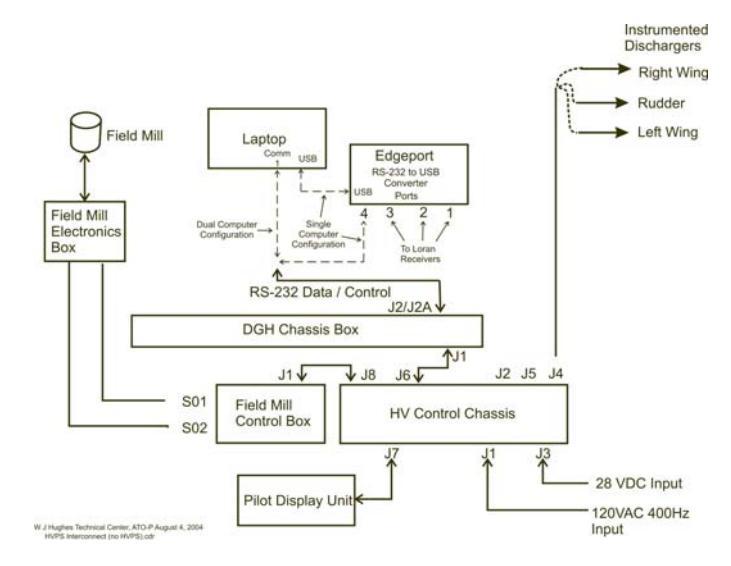
Figure 10: Field mill and instrumented dischargers recording configuration.

A field mill was installed to measure the electric field due to airframe charging. A flight data package was installed to permit operator control and data collection from the field mill plus the Loran-C receivers and to record instrumented discharger currents. Figure 10 shows the field mill and discharger configuration and Figure 11 shows the receiver package diagram.

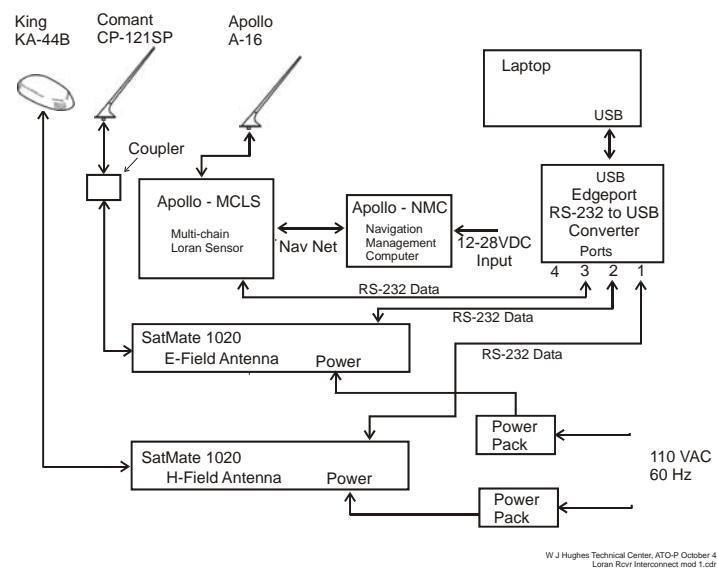
Figure 11: Loran receivers aboard N50 for ground and airborne testing.

Two Locus SatMateTM Model 1020 receivers were installed, one with e-field and one with h-field antenna. A II-Morrow ApolloTM 2010 legacy (hard-limited) receiver was installed, with its e-field antenna, and the Apollo 2101 Navigation Management Computer to provide serial-port output of necessary data for the tests.

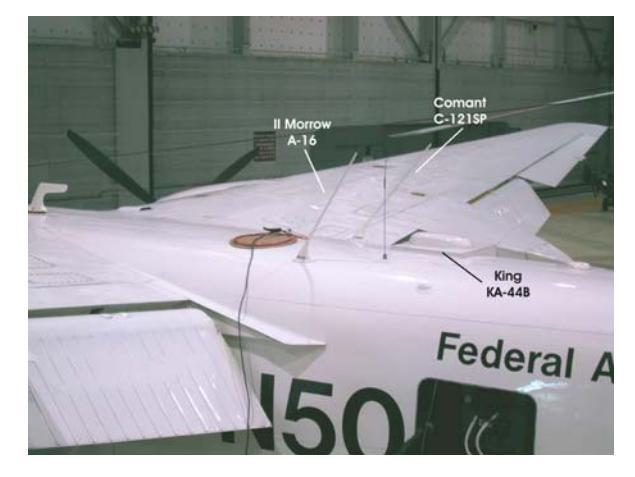
Figure 12: Test antennas on N50

The aircraft was skin-mapped [14] to establish appropriate locations for the antennas. Figure 12 shows the final installation, just aft of the wing, on top of the fuselage.

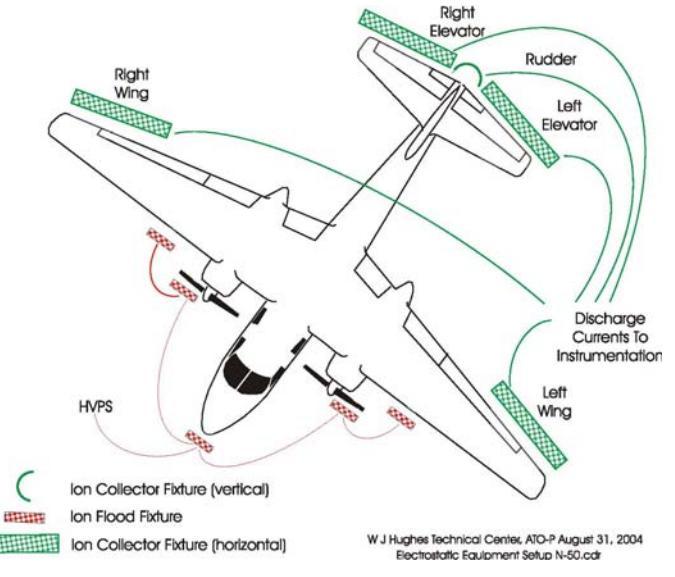
Figure 13: Ion flood and collection fixtures

These requirements are met by unique equipment and procedures developed by consultant Robert Truax, who was employed to provide the ground system. His technique is illustrated in Figure 13 and is the same as that employed for the Ohio 1982 and Illgen 1999 tests. The high-voltage

power-supply shown in Figure 13 liberates ions using standard airframe dischargers placed near the leading edges, with applied voltages up to 50 kV, a sufficient drive voltage determined from long experience. The charge-pumping characteristic of this arrangement allows the airframe to achieve the necessary voltage to begin discharge activity. The photographs in Figure 14 show part of this system in use at FAATC.

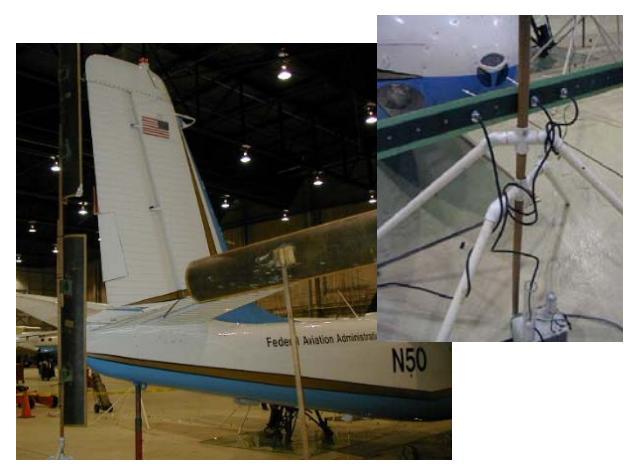
Figure 14: Flood power supply, nose flood fixture and collector fixtures near N50

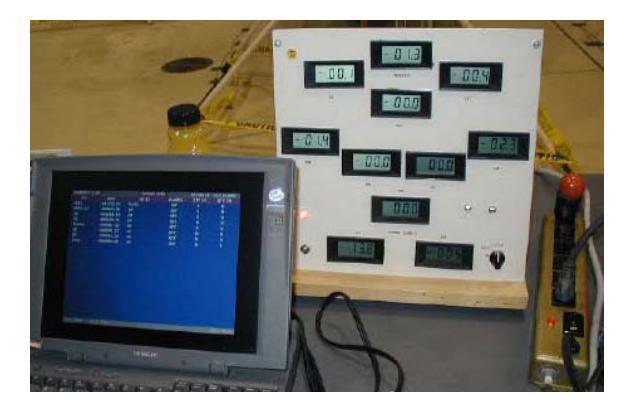
Figure 15: Ground system high voltage and current monitor panel

Figure 15 shows the combination analog and digital panel fabricated by TCO Mfg. to meet the ground system control and data collection requirements.

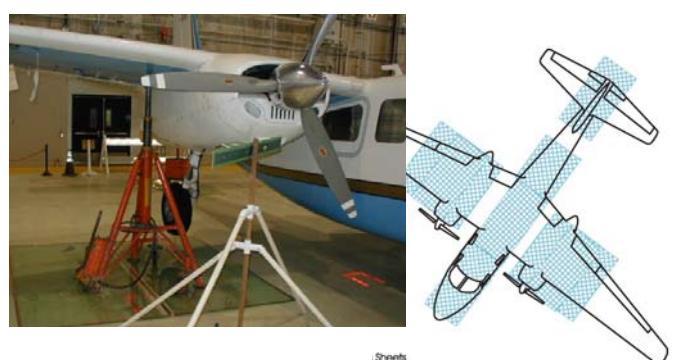
618: Acrylic sheets isolate the aircraft from ground.

For the Aero Commander it was necessary to elevate the airplane on jacks to raise the belly and the various antennas and a laser reflector mirror cluster far enough above the hangar floor that electrical leakage would not interfere with the measurements. The jacks and tail-stand were placed on acrylic sheets for insulation, as shown in Figure 16.

Conductive tape was placed around the periphery of each sheet to "catch" any stray currents escaping from the aircraft. The tape was connected to the metering panel to account for any currents which flowed across the acrylic sheets as streamers. The aircraft body was also protected from ground with the same acrylic-sheet treatment.

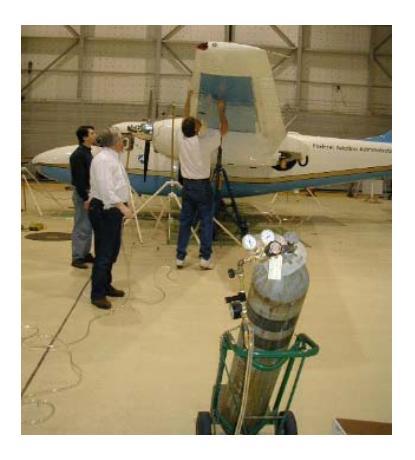
Figure 17: The team assembles the nitrogen purge equipment to maintain fuel system safety during charging.

An Industrial Scientific Corporation Multi-Gas Monitor was used to measure both percent oxygen and lower explosive limit (LEL) by placing a tee in the outflow tube. This method allowed the fuel vapor to be vented outside the hangar while providing a sampling port inside the hangar to connect the TMX412 Monitor. See Figure 17.

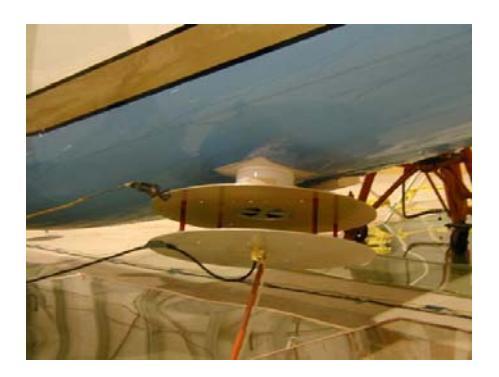
Figure 18: Field Mill calibration fixture in use

The field mill was calibrated to 100 kV/m by applying 0 to - 5 kV to the outer plate in steps, and then multiplying by 10 to account for the close plate spacing. A calibration curve was drawn for the field mill.[19]

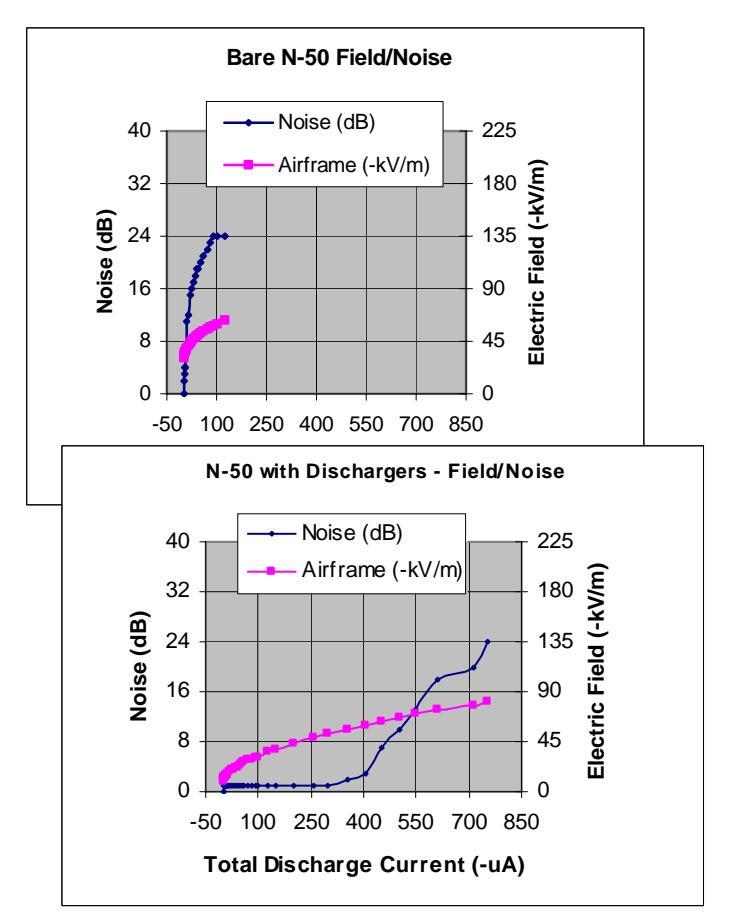
Figure 20: Aero Commander N50 (2004) with and without dischargers in simulated p-static.

Figure 20 gives a brief digest of some of the data recorded during the ground test sequence, in the same format used for the earlier tests, for comparison. By now it should come as no surprise that the addition of well-designed dischargers limits the airframe electric field and significantly reduces the p-static noise output.

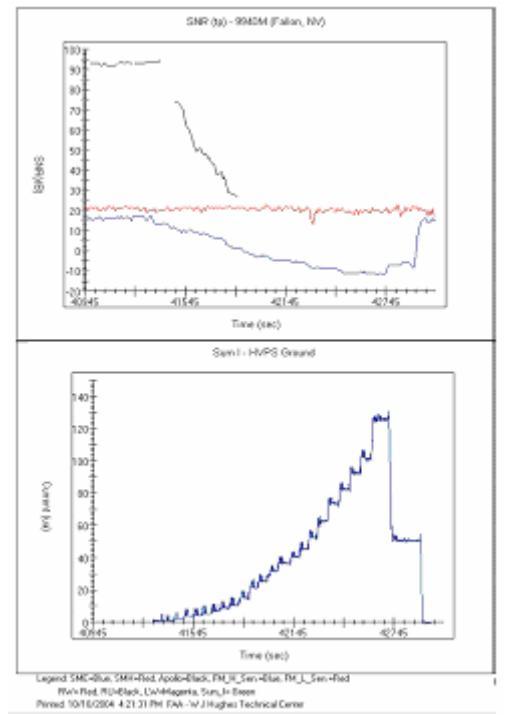
Figure 21: N50 SNR data for simulated 9940M signals vs. airframe electric field and discharge current; no dischargers.

The legacy receiver (black) was clearly having difficulty dealing with the increased noise as discharge current increased. The SatMate e-field receiver showed the familiar pattern: more discharge noise caused reduced SNR until navigation finally stops. The SatMate h-field receiver continued essentially unaffected. The momentary change in h-field SNR somewhat above -50 μ A of discharge current is not yet explained, but is coincident with loss of the e-field trace for 9940Y. There is no clear reason why the two events should be related.

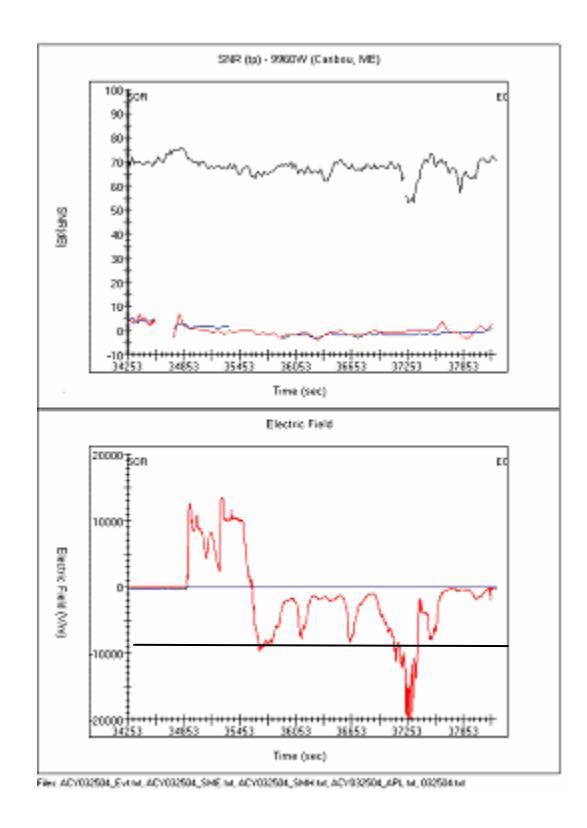
Figure 22: Flight 3/25/04 – P-static encounter; effect on legacy receiver

Figure 22 shows an overview of results of the March 25, 2004 flight test [25], which followed the ground electrostatic calibration. For this flight, all dischargers were removed from the airframe except for three TCO DD-2 units, one at each wingtip and one at the top of the vertical stabilizer. These dischargers were instrumented so that current flow could be observed.

Takeoff occurred at t=34853 and the field mill showed a high positive reading beginning immediately at wheels-up, followed by a more typical negative field values enroute. There were four negative-charging features, three of which were not specifically called out in the flight log but which may have been cloud encounters. It is clear that the fourth encounter with airframe charging produced the maximum field strength for this flight, and it was coincident with a 3-dB reduction in SNR for the Apollo legacy Loran-C receiver, on the 9960W (Caribou) station. Otherwise, aside from a curious increase in SNR during taxi, the Apollo Caribou data variations seem not to be correlated with flight conditions.

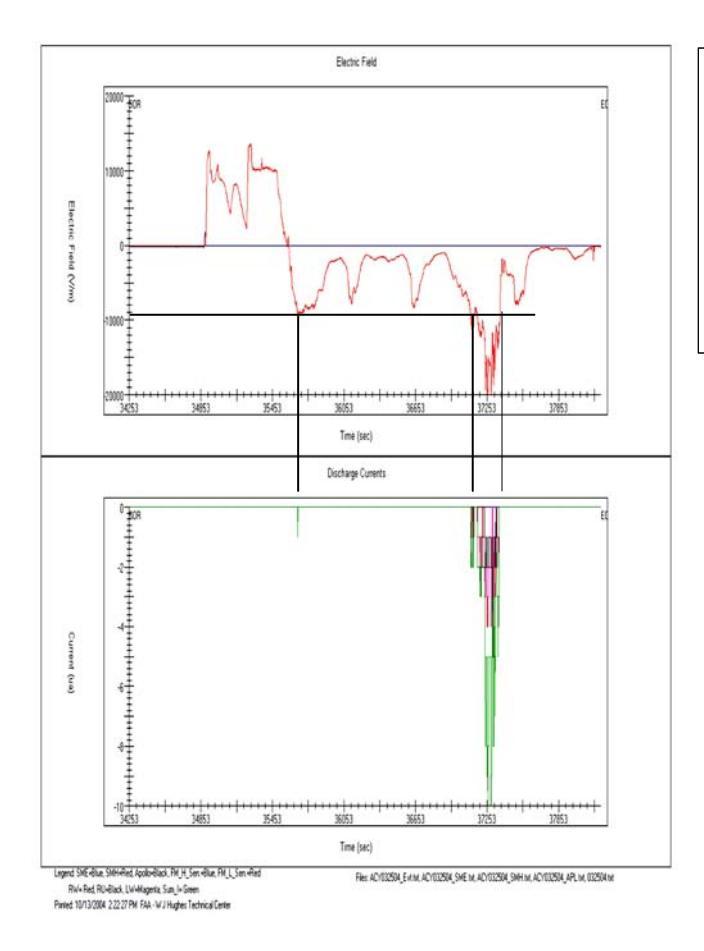
Figure 23: Flight 3/25/04 – Discharge Currents and Field Mill Data

Figure 23 adds the dimension of discharger current to the 3/25/04 flight data. The top trace is the same as the lower trace of Figure 22, and the bottom trace shows the currents observed at each of the three instrumented dischargers. It appears from the chart that the corona threshold for this discharger installation is ~ -9,500 V/m at 7,800 MSL on this day. We see individual currents from the left (magenta) and right (red) wingtips and from the tail-tip (black) which are proportional to the field when it is in excess of this threshold. It is instructive to compare the flight data with ground data. There is also (in green) the sum of all discharge currents, which is of importance in SNR effects prediction.

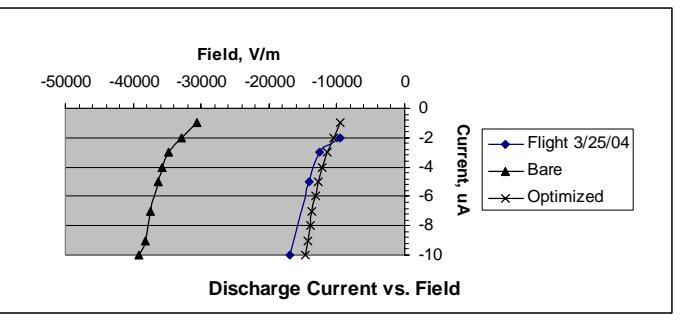
Figure 24: Flight 3/25/04 Compared with ground calibration data

Figure 24 relates the flight observations to ground electrostatic calibration data. The flight data plot is the cumulative discharger current observed on 3/25/04. The

other plots are from the three ground calibration tests already discussed. The "bare aircraft" test showed that for a given discharger current to flow, a relatively high field strength was required. We know that this effect reflects a high corona threshold and a potentially noisy airplane, possibly due to suboptimum discharger design or placement. The flight data in this case more closely resembled the "optimized" airplane on which modern-day dischargers were placed in optimum locations.

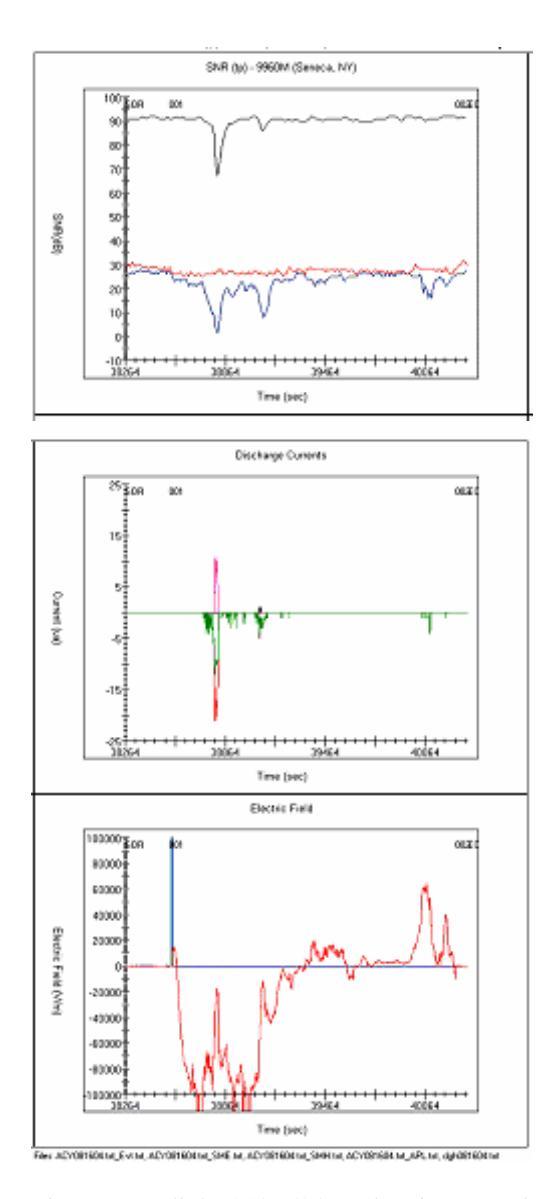
Figure 25: Flight 08/16/04 – Showing p-static effect on efield receivers, Loran-C signal strength, discharger currents, and field mill activity.

The August 16, 2004 flight [26] is one of a series for which the TCO instrumented dischargers were removed and a set of 1/8" diameter brass rods were installed at the wingtips and the tip of the vertical tail. The rods were used here, as they were in the ground tests, to simulate an airplane with no dischargers; one with no resistance between the airframe and the corona point to decouple noise, and with a relatively large diameter at the corona points. We expected to see a higher corona threshold due to the increased trailing-edge radius, and higher stored charge (higher field-mill outputs) on the airframe prior to corona onset. See Figure 25.

The flight was conducted in conditions of low ceilings with rain, and temperatures well above freezing. The "takeoff effect" of apparent positive charging is less visible here due to the much larger chart scale, but it is present. Immediately after takeoff, the aircraft field increased to about 100 kV/m. (This is the limit of the field-mill sensor output.)

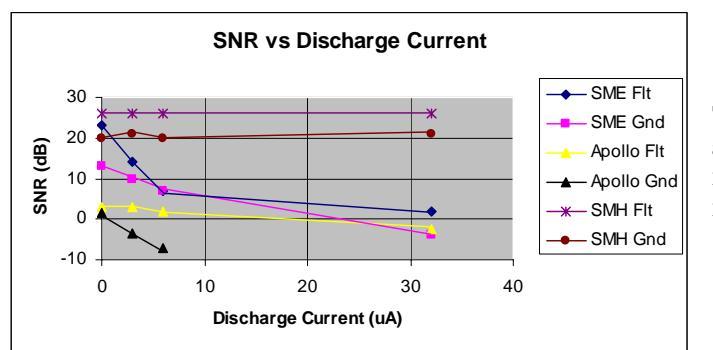
Figure 26: Flight 8/16/04, receiver SNR vs. discharge current. Nantucket (9960W) flight; simulated 9940M ground

Figure 26 presents a graph of these same data. In general, the trends were similar for flight and ground data for each receiver. Exceptions may be due to the nature of the simulated signals used in the ground tests. During experiment set-up there were some concerns over the near-field effects which might be encountered in the hangar. This area remains under investigation. Notice the constant, high-SNR condition for the SatMate with the h-field antenna typical of all flights.
